FUSION LINE SHAPE VERSUS TOUGHNESS IN HY-80 GMA WELDS

T. A. Siewert
R. E. Trevisan
P. T. Purtscher

National Bureau of Standards
U.S. Department of Commerce
Boulder, Colorado 80303

April 1986

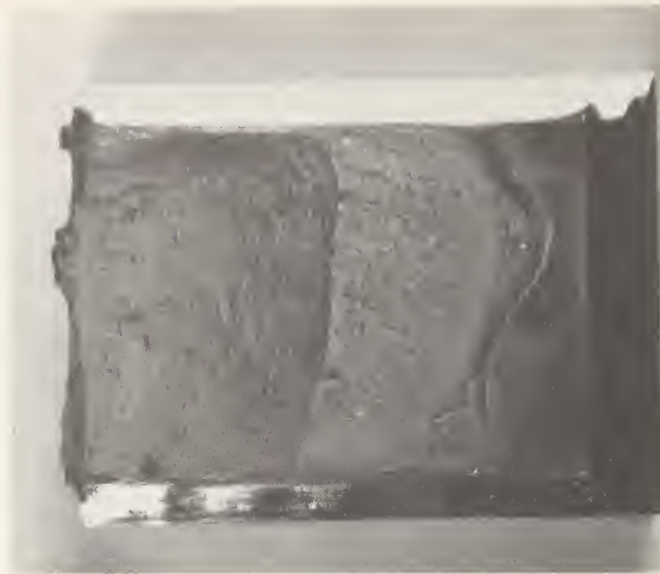
Compressed 2%
(a)

Final Overload
Fatigue Postcrack
J Test Fracture
Fatigue Precrack
Machined Notch

Side Grooved 20%
(b)

Figure 8. Changes in fatigue crack shape produced by precompression.

Two examples of the fatigue precracks produced by the different test procedures and specimen configurations are shown in figure 8. Figure 8a shows a compact tension specimen that was side grooved prior to fatigue precracking. The fatigue precrack front is very irregular and does not meet ASTM E813 requirements. Figure 8b shows an SENB specimen that yielded locally in compression prior to fatigue precracking. The fatigue crack front is relatively straight and is acceptable, according to ASTM E813. Note also that the welding flaw had no apparent effect on the growth of the fatigue precrack, but it did have a decided effect on the growth of the overload crack, increasing crack growth in the vicinity of the flaw.

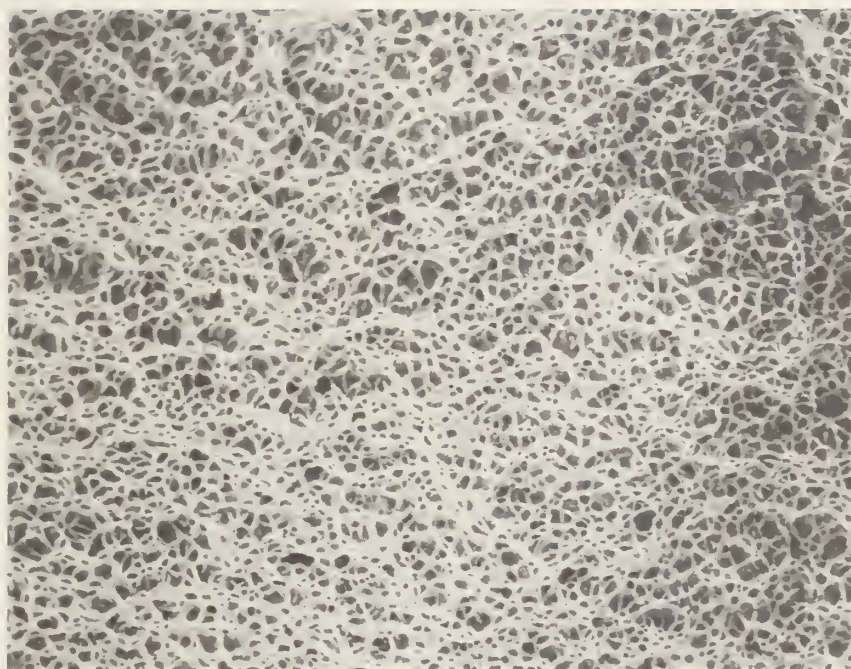
Figure 11. Fracture surface dimple size in the weld.

The location of the crack initiation with respect to the fusion line was determined by the size of the dimples at the initiation site. Figures 10 and 11 show the relative size of the dimples in the base metal and weld metal specimens, respectively. Because the inclusion distribution determines the dimple size and spacing and the weld metal has more inclusions than the base metal, the weld metal fracture surface has more and smaller dimples than the base metal fracture surface. Thus, it was possible to identify the material at the crack initiation.

The fracture initiation location with respect to the fusion line was determined by studying the fracture surfaces, which are well defined in figures 10 and 11. From this SEM examination, we can also follow the crack propagation. The results are summarized in tables 10 and 11. Figure 14 shows one typical pattern, where the crack initiated in the base metal HAZ

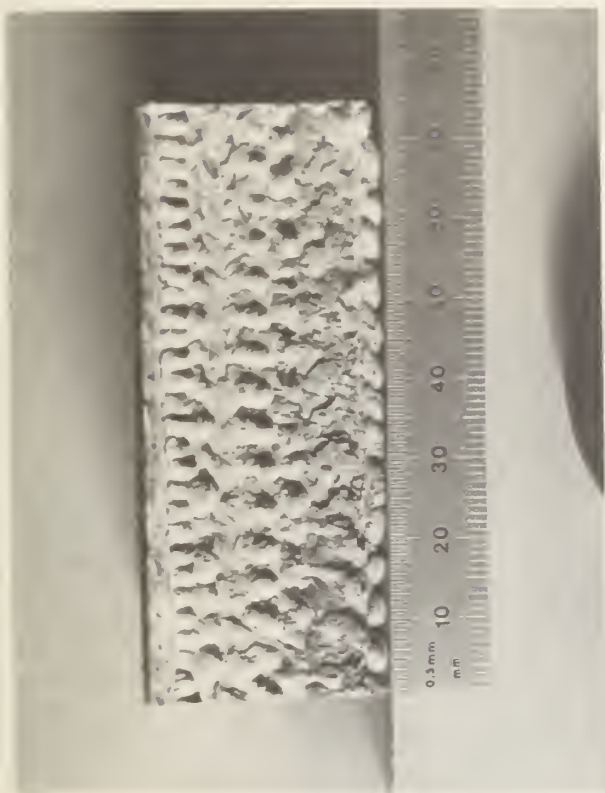
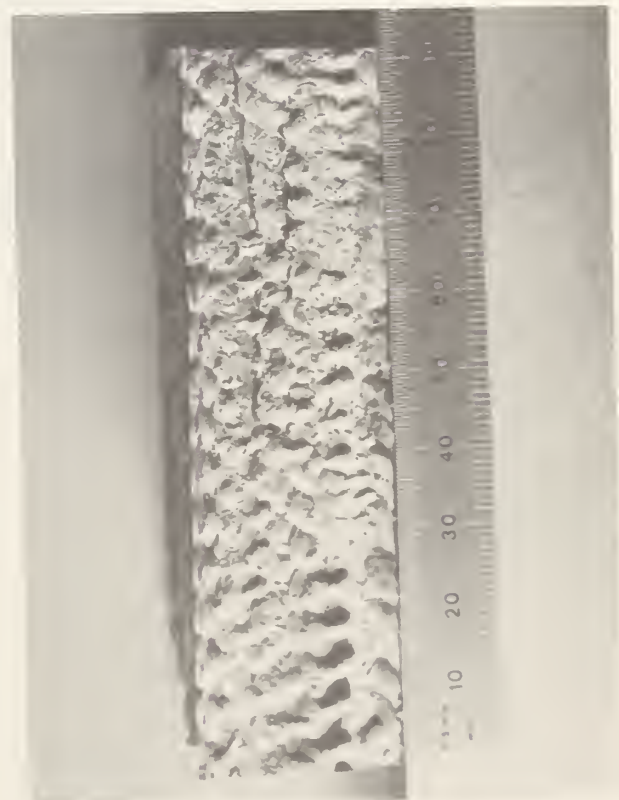
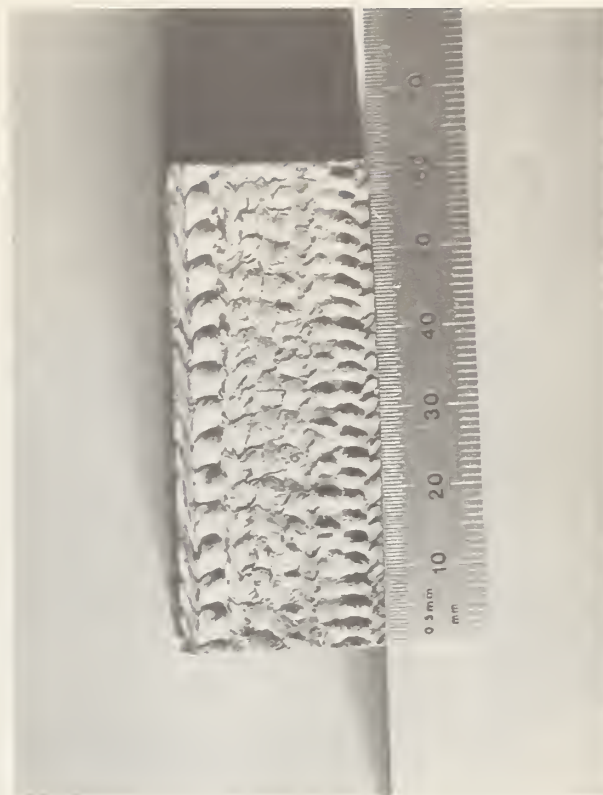
Figure 13. View of the fusion-line surface.

Figure 13 shows the fusion-line surfaces for the four welds produced using stainless steel filler material in order to characterize the texture of the fusion line. This technique shows the entire surface clearly; only a line of which is revealed in conventional transverse sections. The stainless steel weld metal has a different composition and therefore a different viscosity and wetting character than the ferritic welds; however, the fusion surface is representative of the welding arc action (which was duplicated) and the weave pattern. The smooth fusion-line surface of weld 1 (stringer bead technique) is vastly different than the convoluted fusion-line surface for the three welds with the weave techniques. Only small differences are apparent among the three weave patterns; therefore, variable penetration into joint walls and the difference between semiautomatic and adaptive control had

little effect on the fusion-line surfaces for these tests. The spacing and height of the convolutions (ripples) should have a substantial effect on the toughness of welds in which the fusion line is the critical crack path. Such ripples tend to lengthen the fracture path (and thus increase the fracture toughness) and tend to turn the running crack into the tougher weld or base material.

Careful examination of the fusion-line surfaces reveals small, flat areas that could be interpreted as insufficient fusion flaws. These regions, comprising less than 2 percent of the fusion-line surface area, were not observed on the weld radiographs of transverse sections. They could be the weld flaws that were seen on several of the fusion-line fracture surfaces.

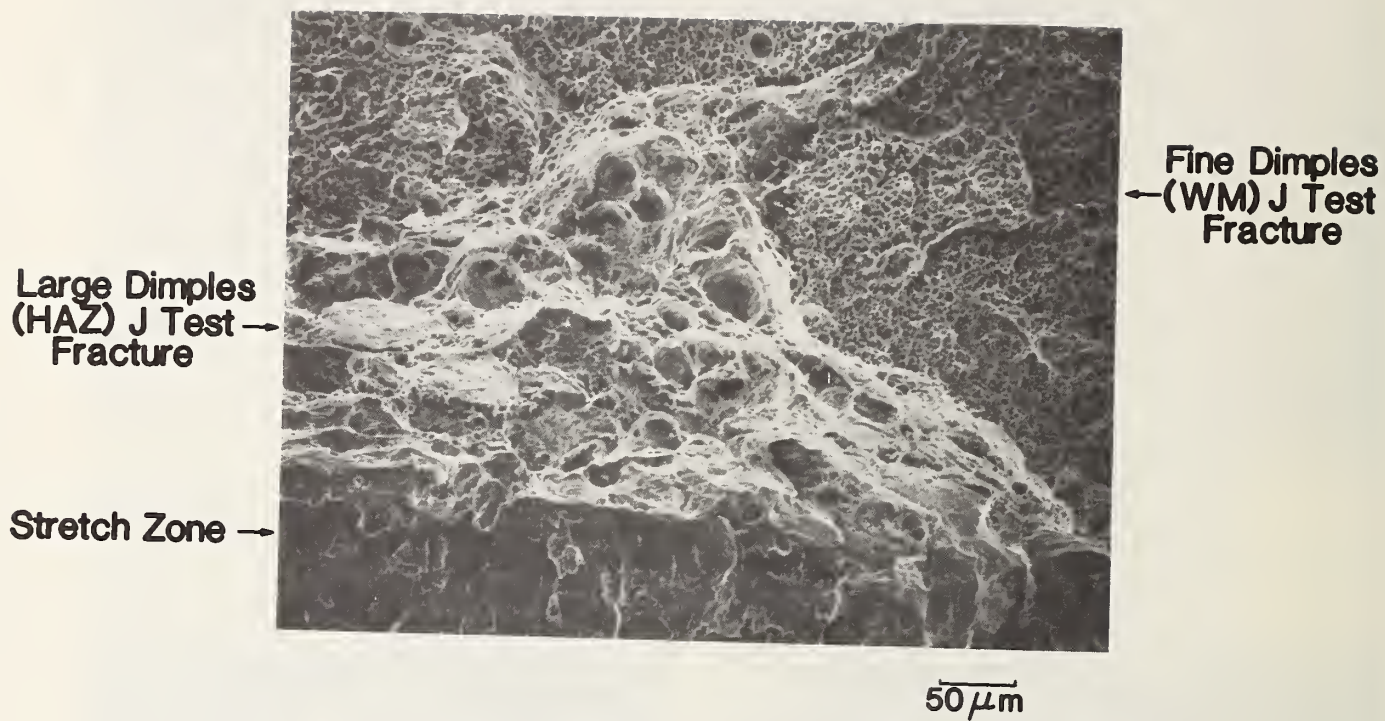
Figure 14. Macrograph showing a fracture pattern of initiation in the HAZ and propagation in the weld.

and propagated into the weld metal (identified in table 10 by HAZ + WM). This type of crack development occurred in specimens 2-CT-1 and 3-CT-4. Figure 15 shows another typical pattern, where the crack initiated at a weld flaw and propagated in the weld (WM flaw). This type of pattern occurred in specimens 1-CT-2, 1-CT-3, 3-CT-1, 3-CT-2, 1-SENB-1 and 3-SENB-1. Figure 16 shows the third typical pattern where the crack initiated and propagated in the weld (WM). This pattern of crack development was present in specimens 4-CT-1, 4-CT-2, 2-SENB-1, and 2-SENB-2.
